TECHNICAL REPORT C-13

Systems Approach to Life-Cycle Design of Pavements

**METHODOLOGY AND EFFECTIVENESS
OF DRAINAGE SYSTEMS FOR AIRFIELD PAVEMENTS**

by
Harry R. Cedergren

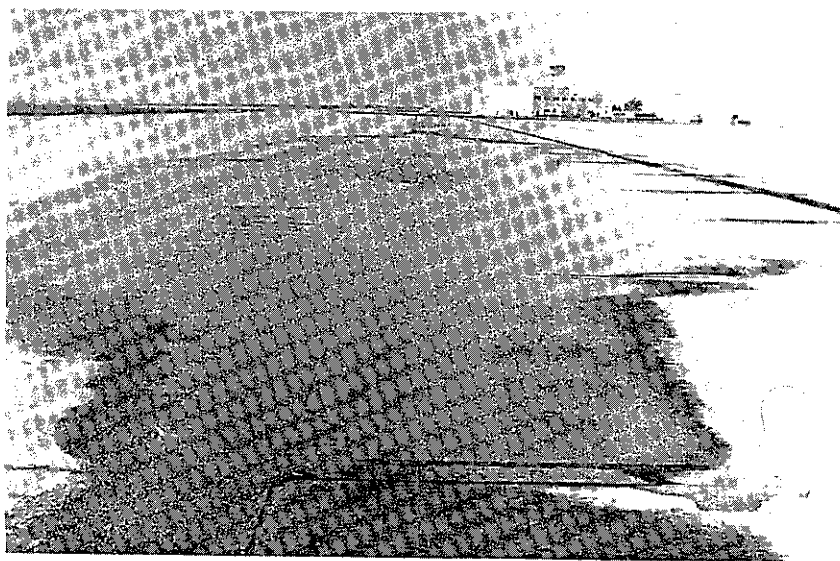
Figure 10. Photo showing large "birdbath" in a wide, flat pavement.

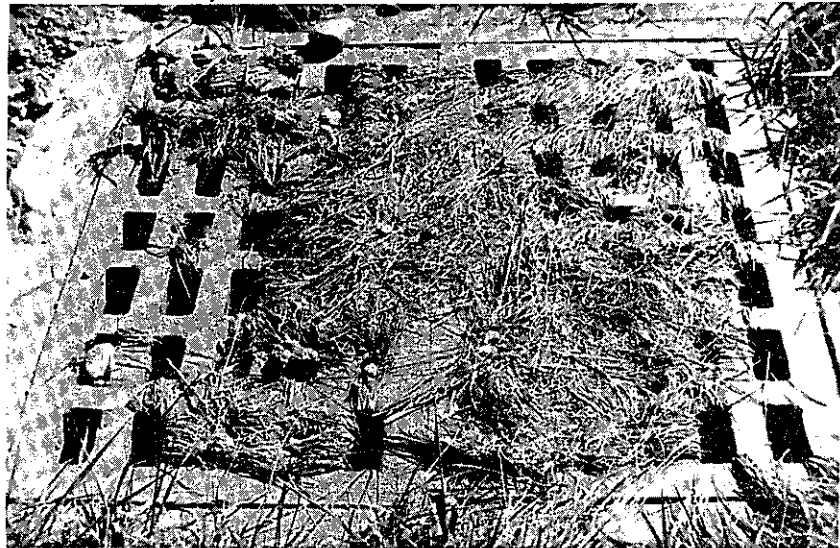
Figure 11. Photo showing common type of clogging nuisance at inlets; requires periodic cleaning by maintenance forces.

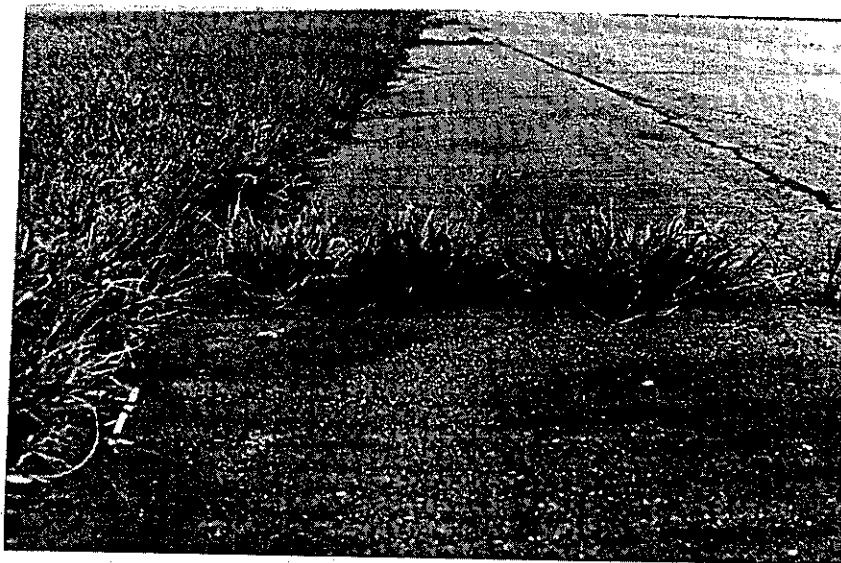
High Sod and Grass at Pavement Edges. When sod and thick grass growth are allowed to develop at the edges of pavements, surface drainage can be severely impeded. Usually, when water stands, it is at outer edges, and this may not be damaging to wide runways; however, it was said to be a factor in the premature destruction of one major runway-taxiway system at a commercial airport. It did not appear to be a major cause of pavement damage at the military air bases inspected in this project, although it might have been a contributing factor in some cases. Figure 12 shows an example high growth along the edge of a taxiway.

Figure 12. Photo showing high sod at the edge of a taxiway having poor subsurface drainage, and poor surface drainage at outer edges.

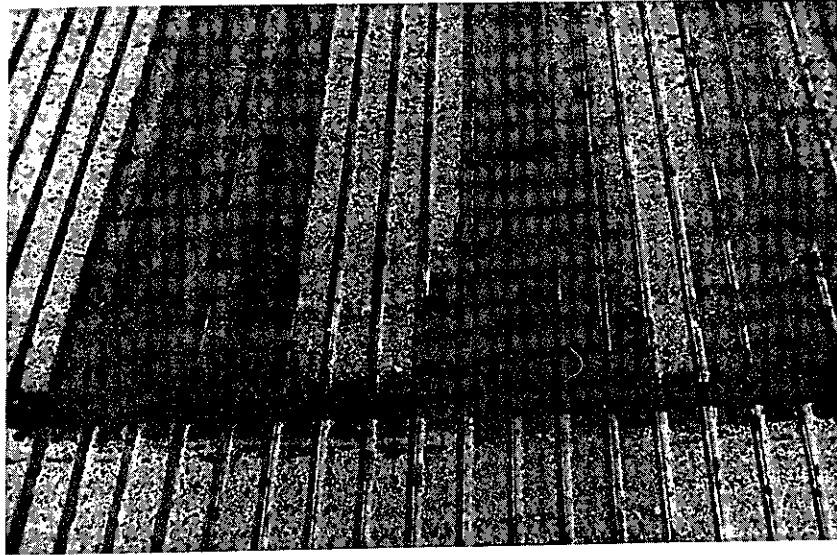
Figure 13. Photo showing diamond-grooved PCC runway; dark stains show that past inflows have entered the construction joint.

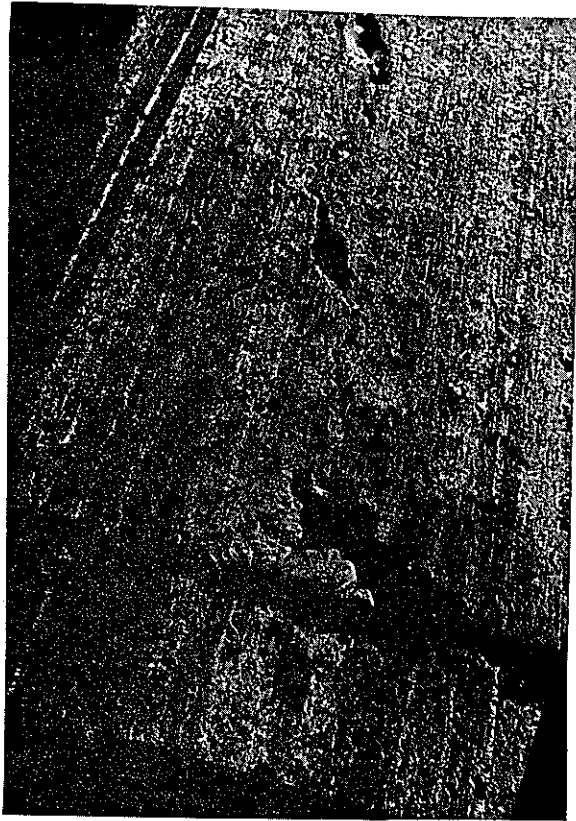
Figure B-11. A main runway; unsealed crack in 16-in. thick PCC pavement.

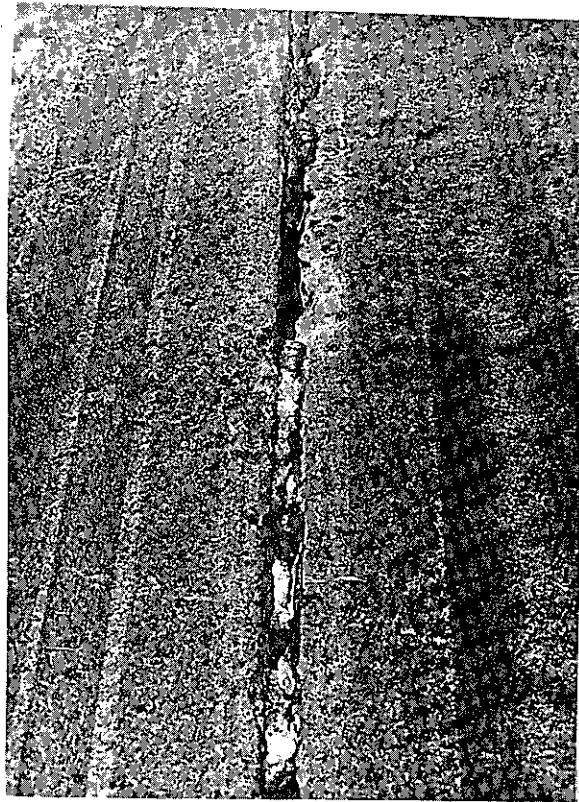
Figure B-13. Main runway; open cross joint with some spalling.

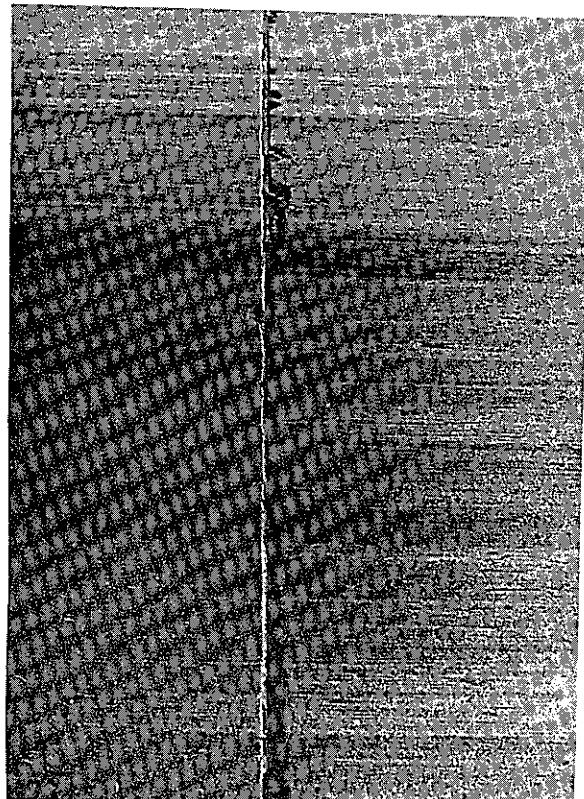
Figure B-14. A primary runway; cross view of an open joint.

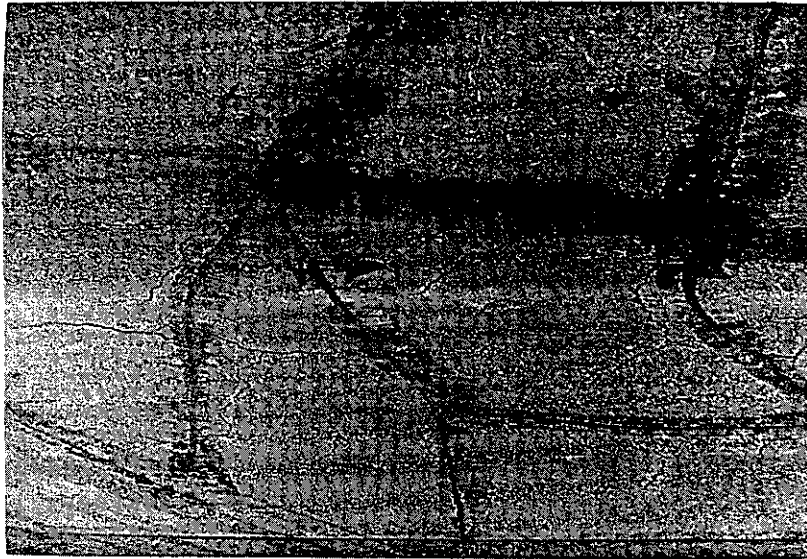
Figure B-17. A taxiway in a moderately heavy traffic area; wide cracks in AC have not yet been covered with a slurry seal.

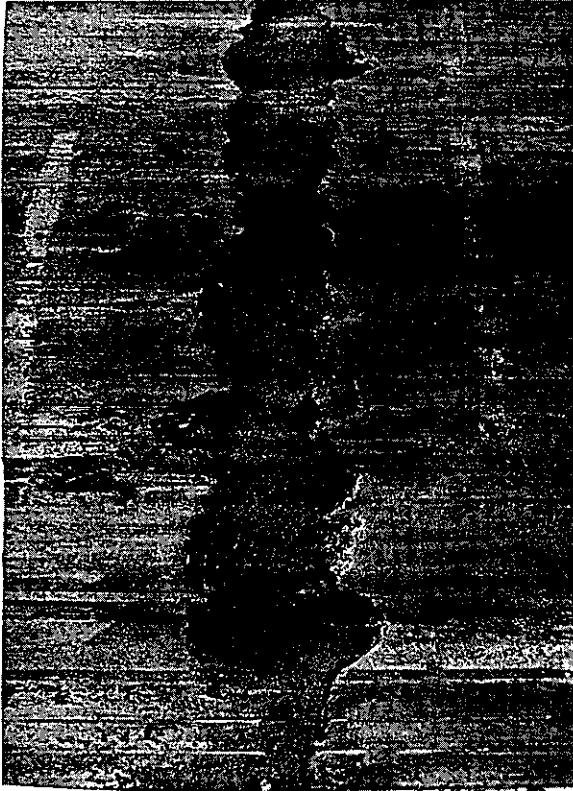
Figure B-18. A main runway; spalled area, about 18-in. wide at maximum; has been patched with AC; may have started as a joint problem, but is big enough to be of structural importance.

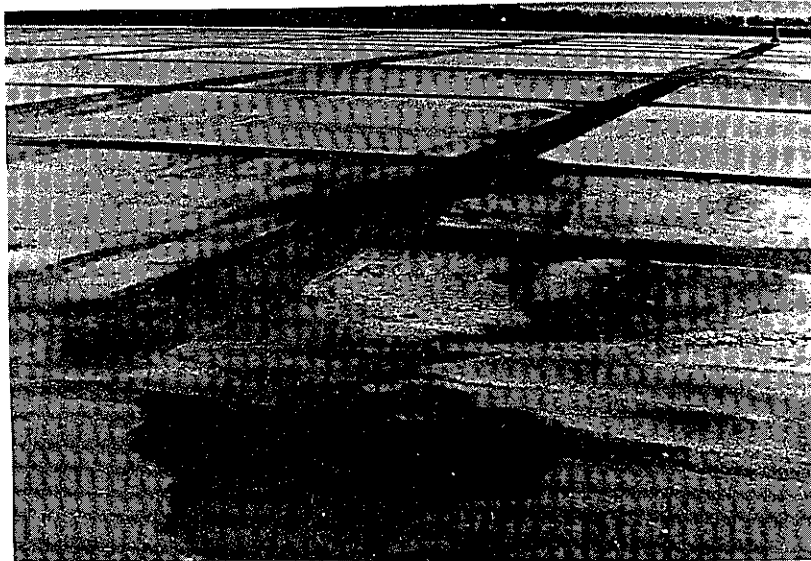
Figure B-19. Extensive damage of pavements; repair of joints has been required; much excess water and bleeding; free water coming out several days after a rain.

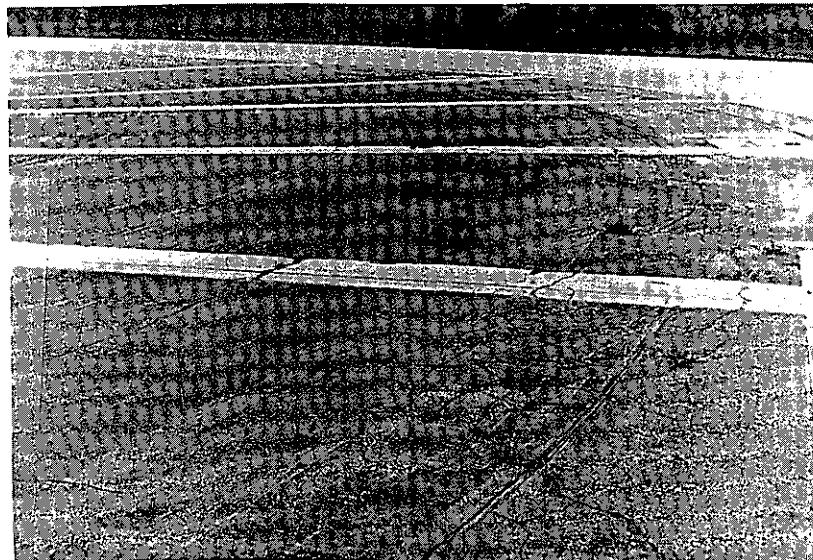
Figure B-20. Severe cracking of thin AC pavement in shoulder of a taxiway; believed due to frost action with liberal supply of water available.

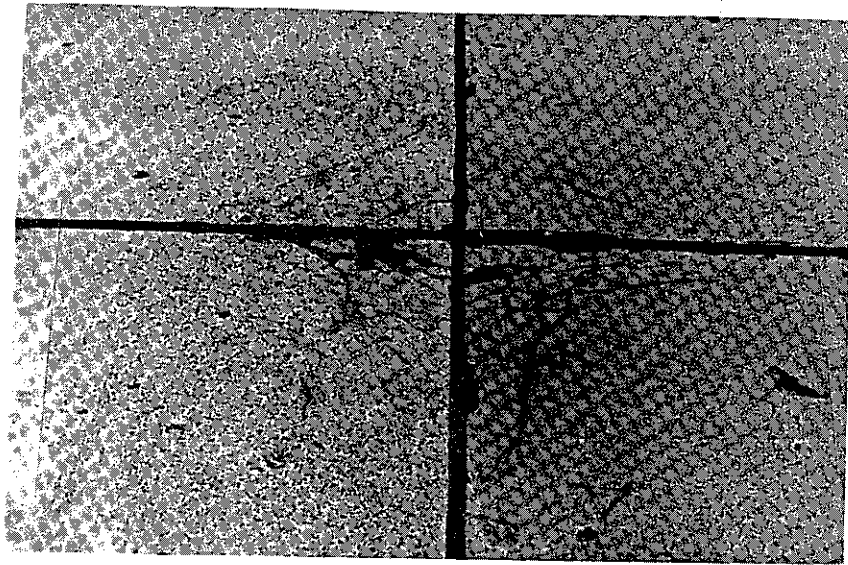
Figure B-21. Taxiway; typical corner "D" cracking in thick PCC pavement; 24"-27" section.

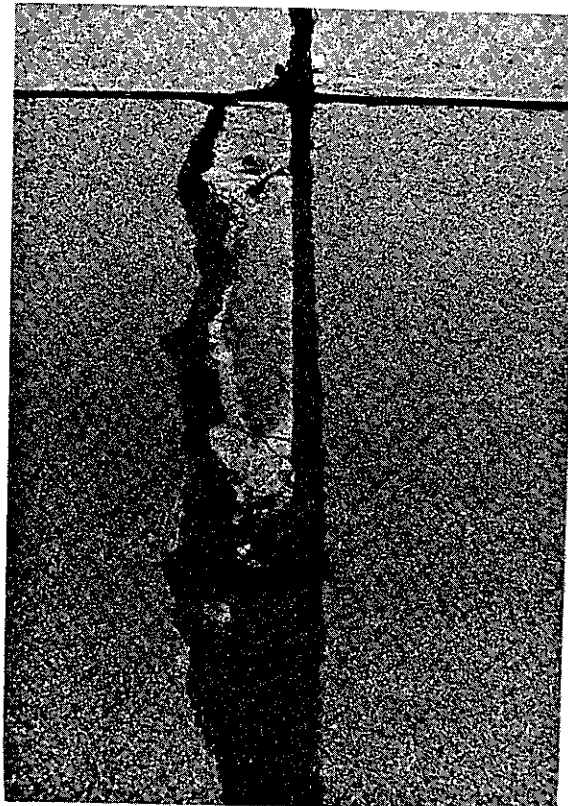
Figure B-22. Operational apron; repaired spall is breaking out; 11-in. PCC on 6-in. PCC and base course.

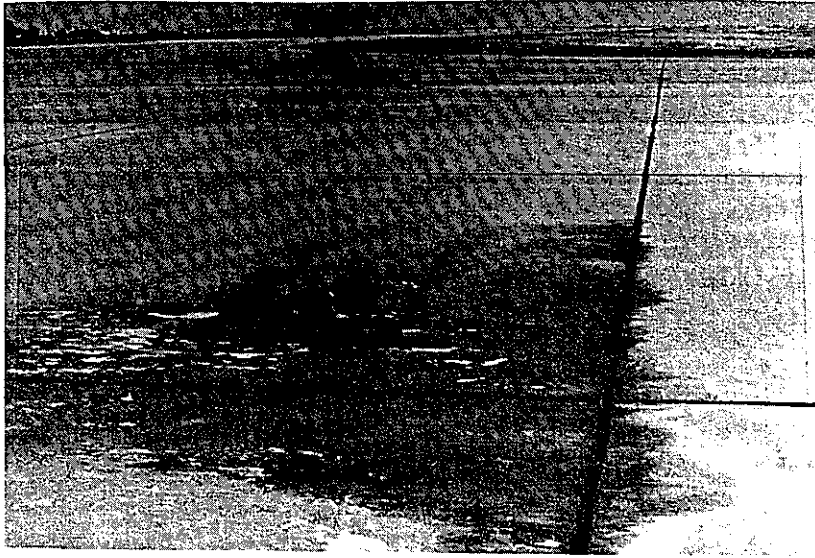
Figure B-25. Warm-up apron near the end of a runway; dark stains indicate possible surging area (water squeezed out by planes); warm-up apron at end of runway at taxiway.

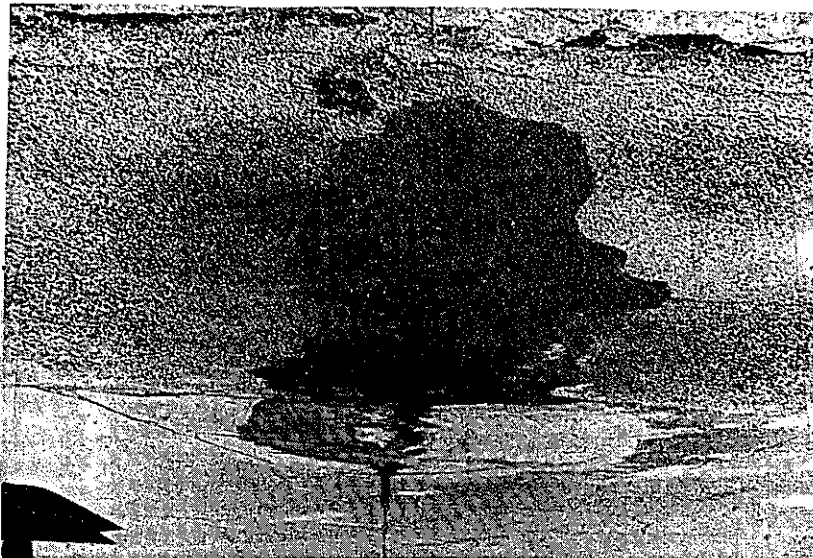
Figure B-26. Old runway, bad bleeding, much pavement damage from excess water.

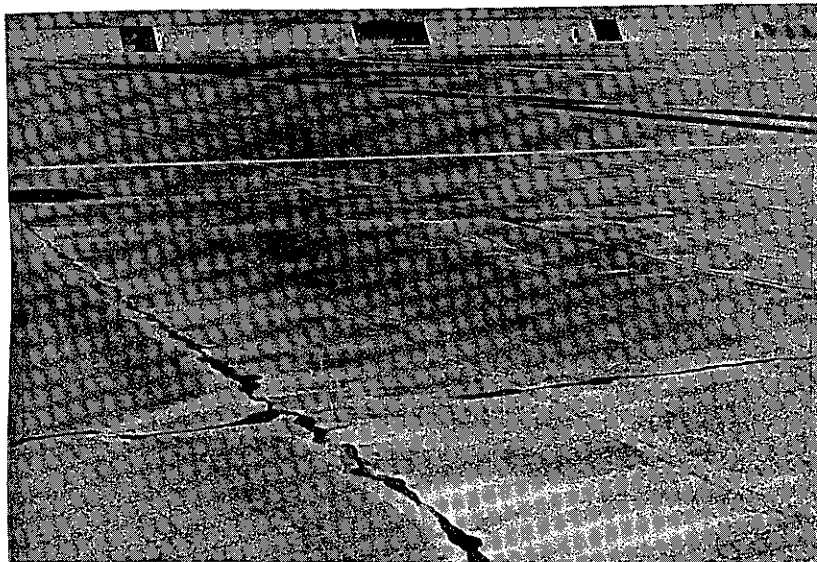
Figure B-27. Parking apron; excessive bleeding shows here; much patch work and joint repairing has been required.

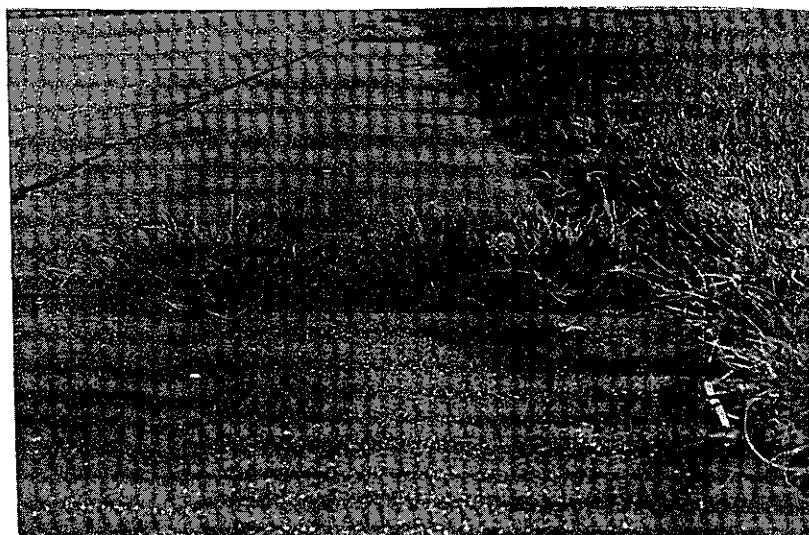
Figure B-28. Taxiway; high sod along edge; this is in a "bathtub" condition; profuse grass in cracks in AC is indication of plentiful water supply; a very common condition.

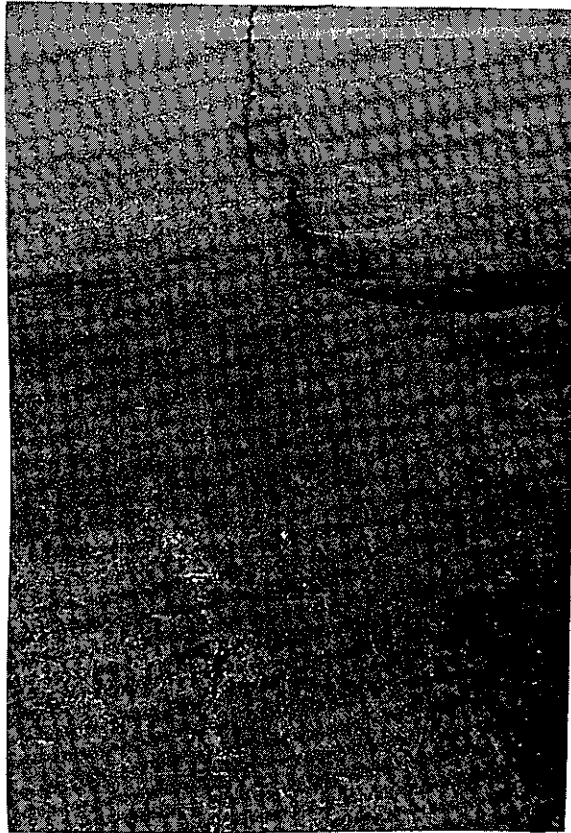
Figure B-31. Parking apron; reflection cracks in 2-in. tar-rubber overlay on 16-in. PCC.

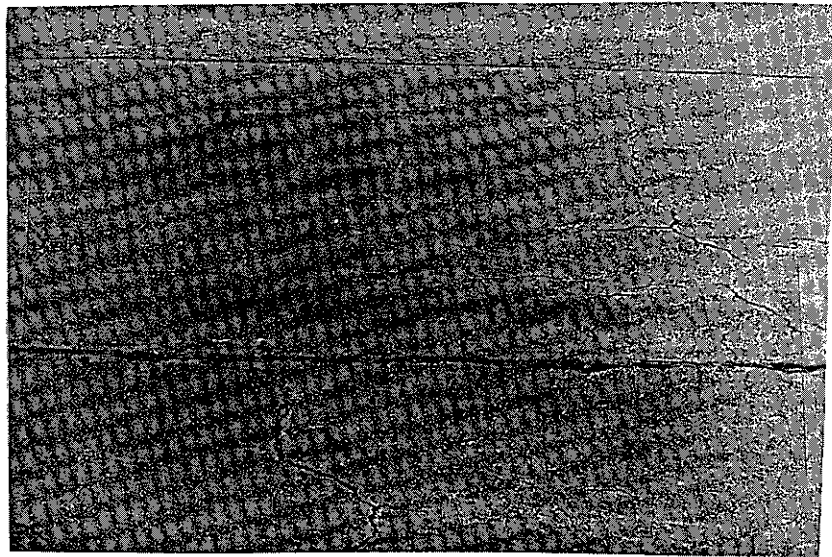
Figure B-32. Parking apron; reflection cracking in 7-in. AC overlay on 8-in. PCC.

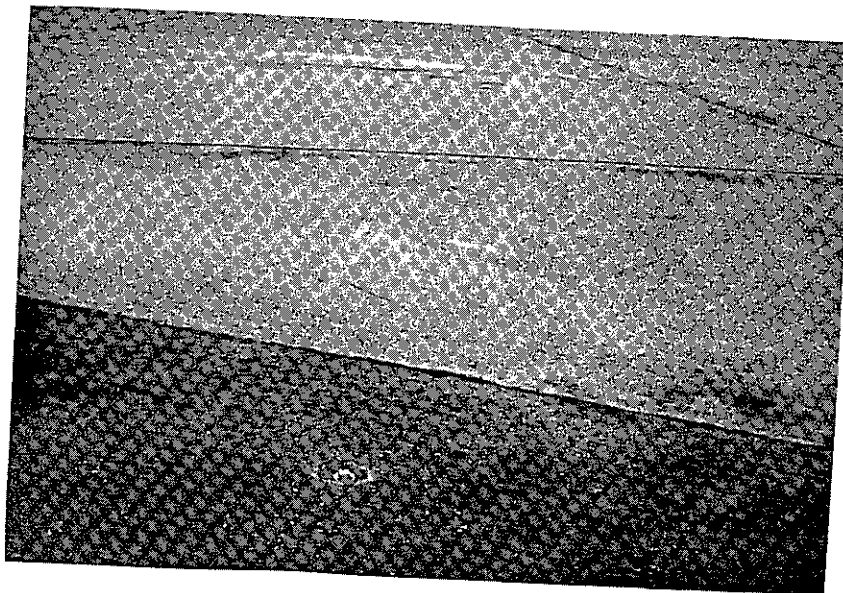
Figure C-5. Cross view of Wells 4 and 5; shows general appearance shortly after installation; Well 4 (near upper center) barely visible; dark stains are signs of surging or bleeding in this area; dry pavement today.

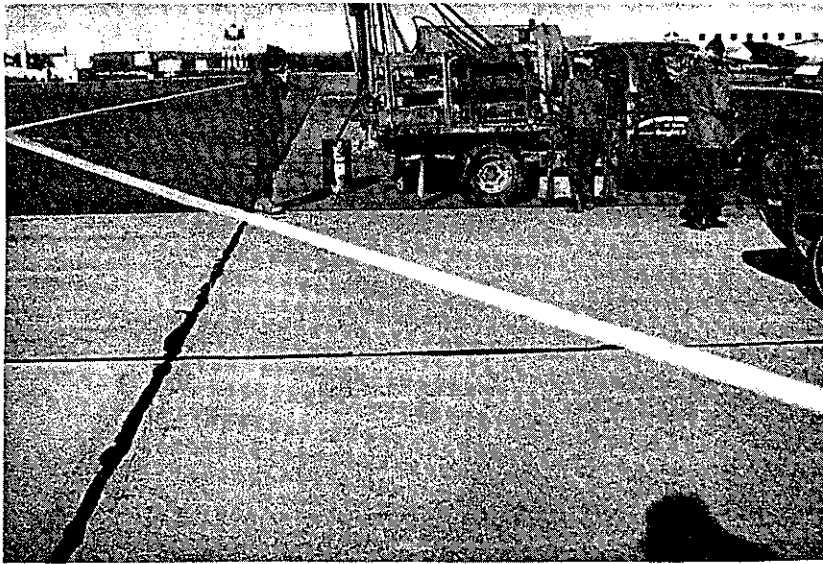
Figure D-4. View of drilling equipment at Well 6; is in 20-in. thick PCC at SW Warm-up Apron and Taxiway; dark stains suggest some bleeding may occur here; no excess water at time of drilling.

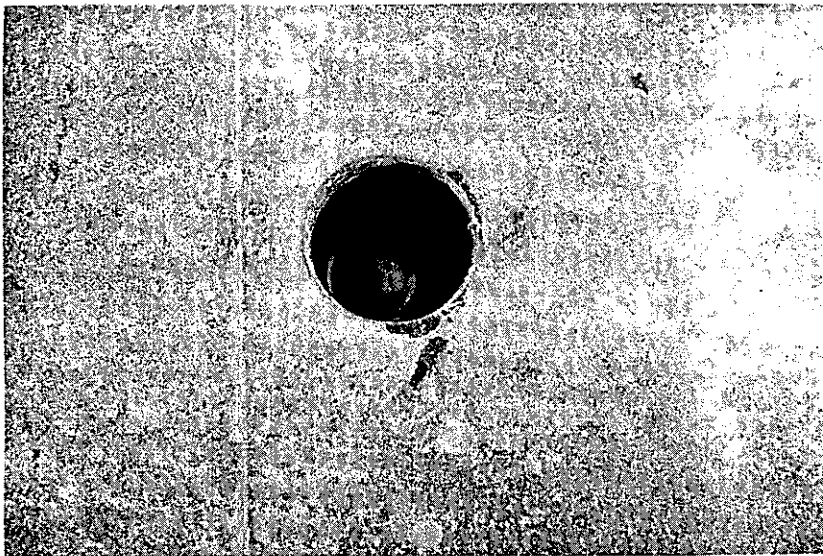
Figure D-5. Looking down into hole 2 after drilling to 18-in. depth; water stood 12 inches below top of pavement--from water used in drilling hole; light is being reflected off water in hole.

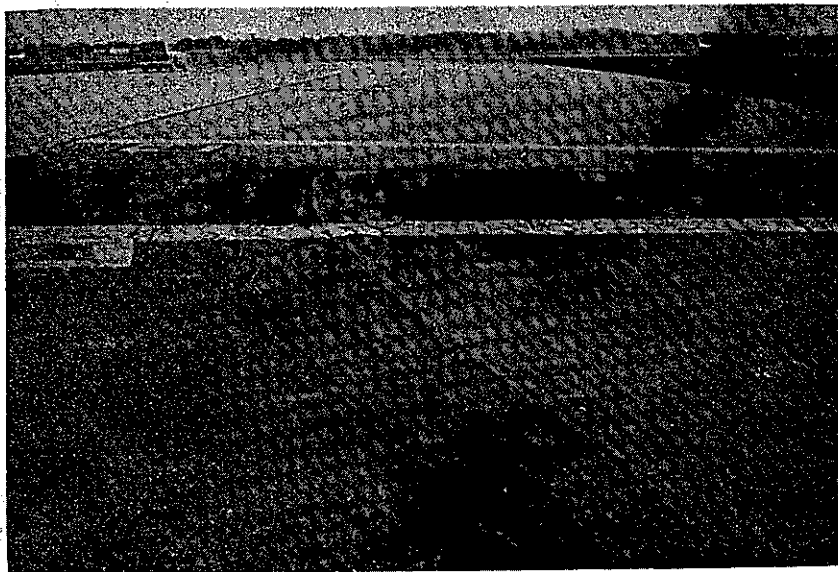
Figure E-11. Looking toward site of Wells 1-4 in Taxiway 14; deteriorated shoulder in foreground, has been damaged from excess water and frost action; the wells were installed later in vicinity of vehicle.
